CASE STUDY

Heavy Oil Well Surface Casing Vent Flow & Gas Migration

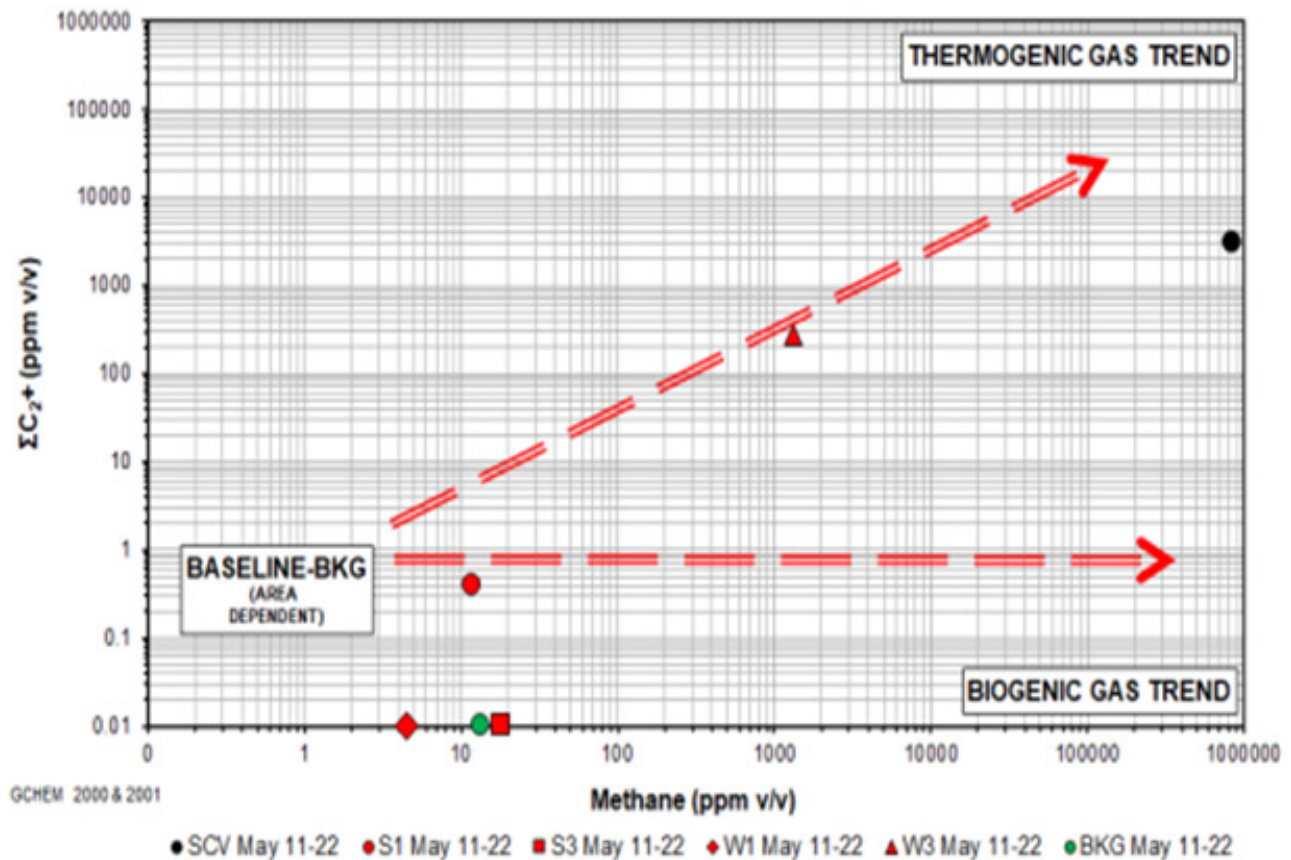
Figure 1: Carbon Isotope Analysis

360 was engaged to address wellbore integrity issues. Sucker rods and production tubing were removed and a retrievable plug was set at 593.9 mKB to allow for the wellbore to stabilize. Logging tools, including a fibre-optic cable deployed for noise/temperature, radial cement bond, and cased hole analysis, identified potential annular gas sources from below plug back depth and the Colorado formation. In-soil and surface casing gas analysis confirmed thermogenic gases from the Colorado formation.
