## CASE STUDY

# Wheatley, Ontario Explosion

WHAT HAPPENED, THE IMPLICATIONS, AND FUTURE PREVENTION

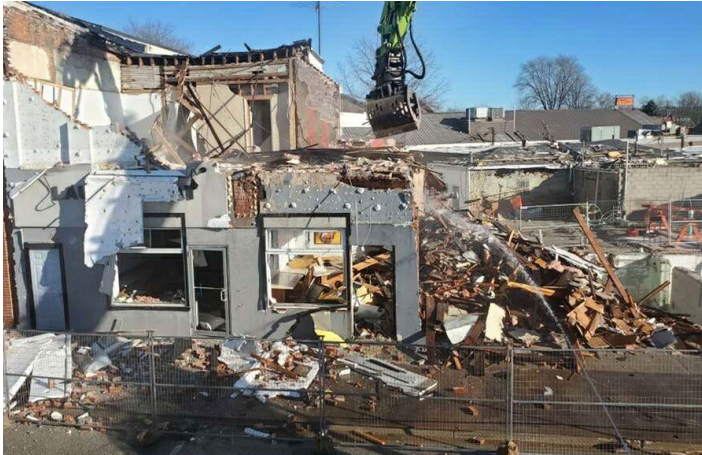
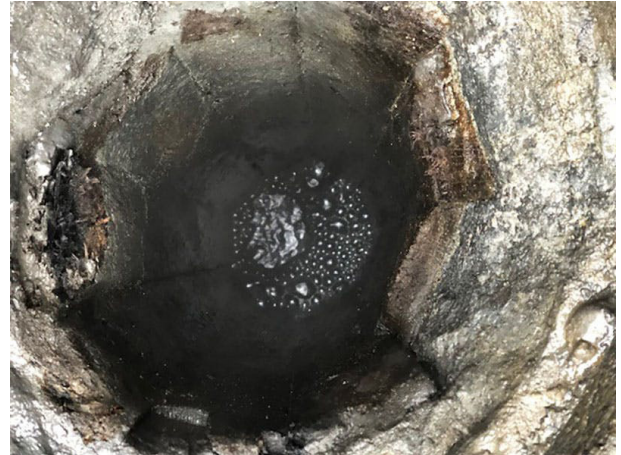
- All above-ground buildings adjacent to the explosion site were demolished, and residual concrete foundations and basements were removed in anticipation of discovering more undocumented wells during the excavation process.

- The suspected source gas well is scheduled to be re-abandoned to modern standards, and monitoring will remain in place to ensure that gas concentrations in the groundwater dissipate to safe levels.

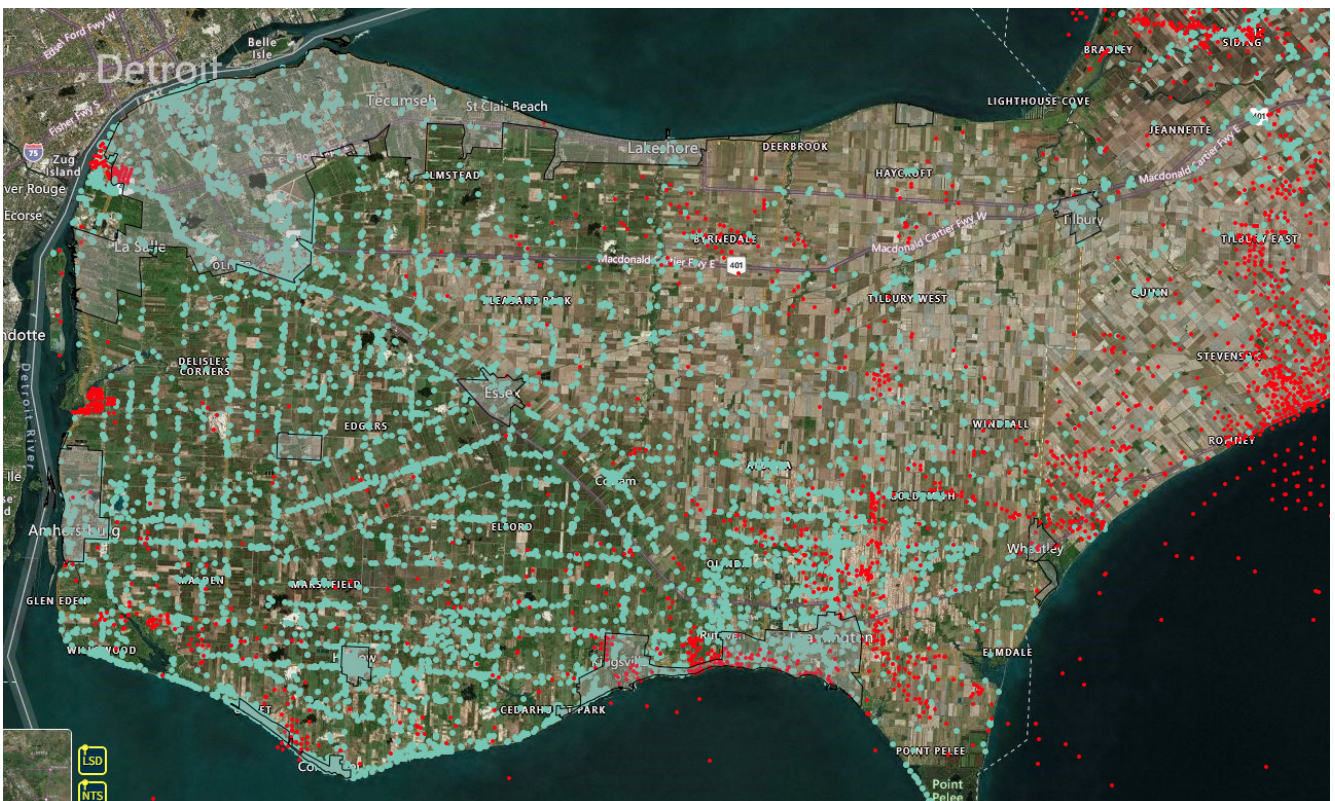
## Well Map

The map below illustrates the water (blue) and gas (red) wells in western Chatham-Kent, and neighboring Essex County.
