CASE STUDY

Wheatley, Ontario Explosion

WHAT HAPPENED, THE IMPLICATIONS, AND FUTURE PREVENTION

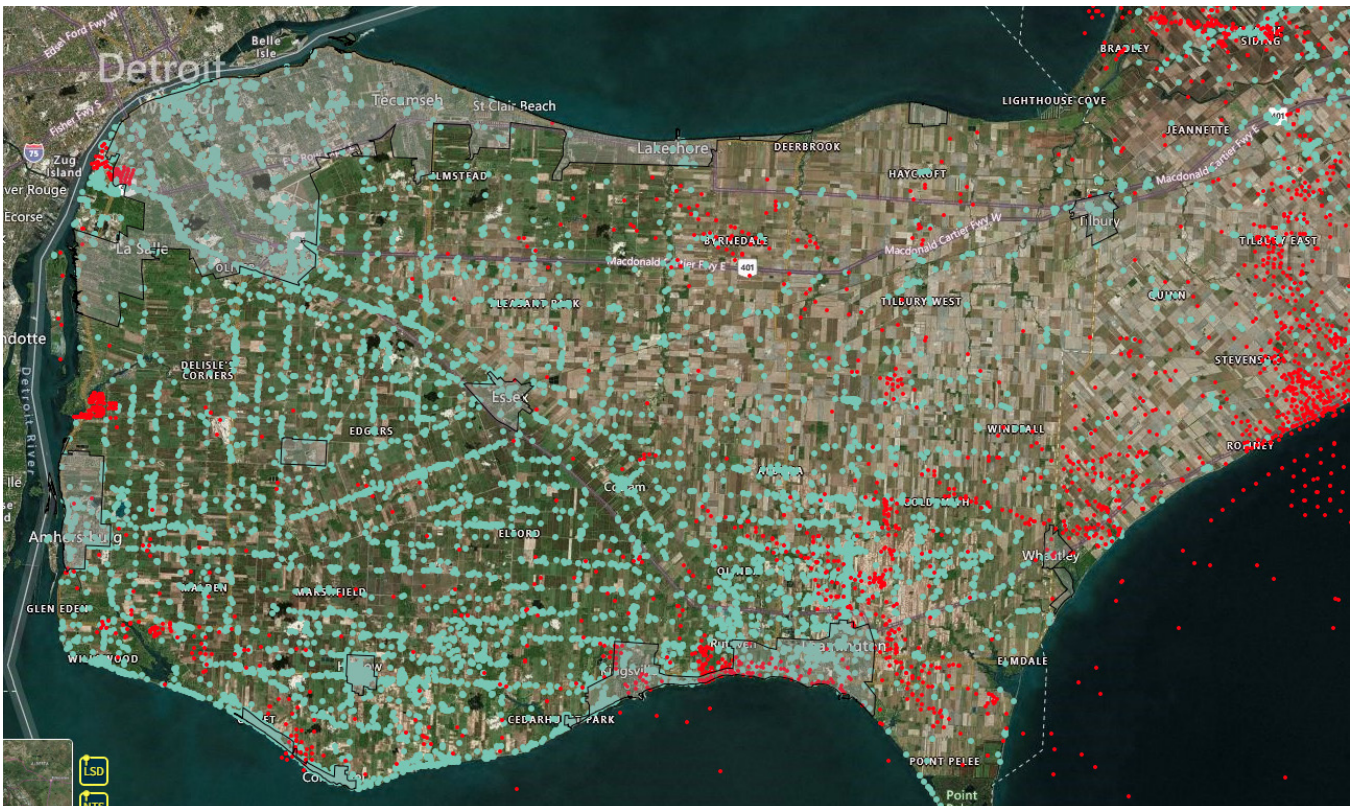
The map above illustrates the water (green) and gas (red) wells in western Chatham-Kent, and neighboring Essex County.
